## **Savannah Tip No: 22**

### **Savannah VG and XL Flap Adjustment.**

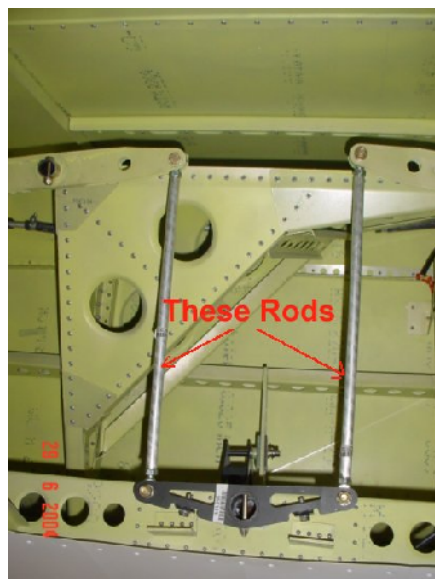
The ICP construction manual calls for the adjustment rods connected to the bell-crank (aileron horn) on the torque tube to be adjusted to their minimum length for the VG/XL models. This has the effect of reducing the AOA of the flaperons relative to the rest of the wing, and reducing the amount of flap available at the 2off flap settings. It also has the effect of moving the centre of lift forward, which then requires more down elevator trim for straight and level flight.

Aircraft with the control rods adjusted to the minimum length may not have enough down trim available at rearward CG's (such as when fully loaded) to neutralise the stick forces for hands off straight and level.

Consultation with ICP has resulted in ICP recommending that the control rods be returned to the original length to alleviate this problem.

A better solution would be to add a little more down angle to the engine by adding an extra washer to the top two mount points of the ring mount.
