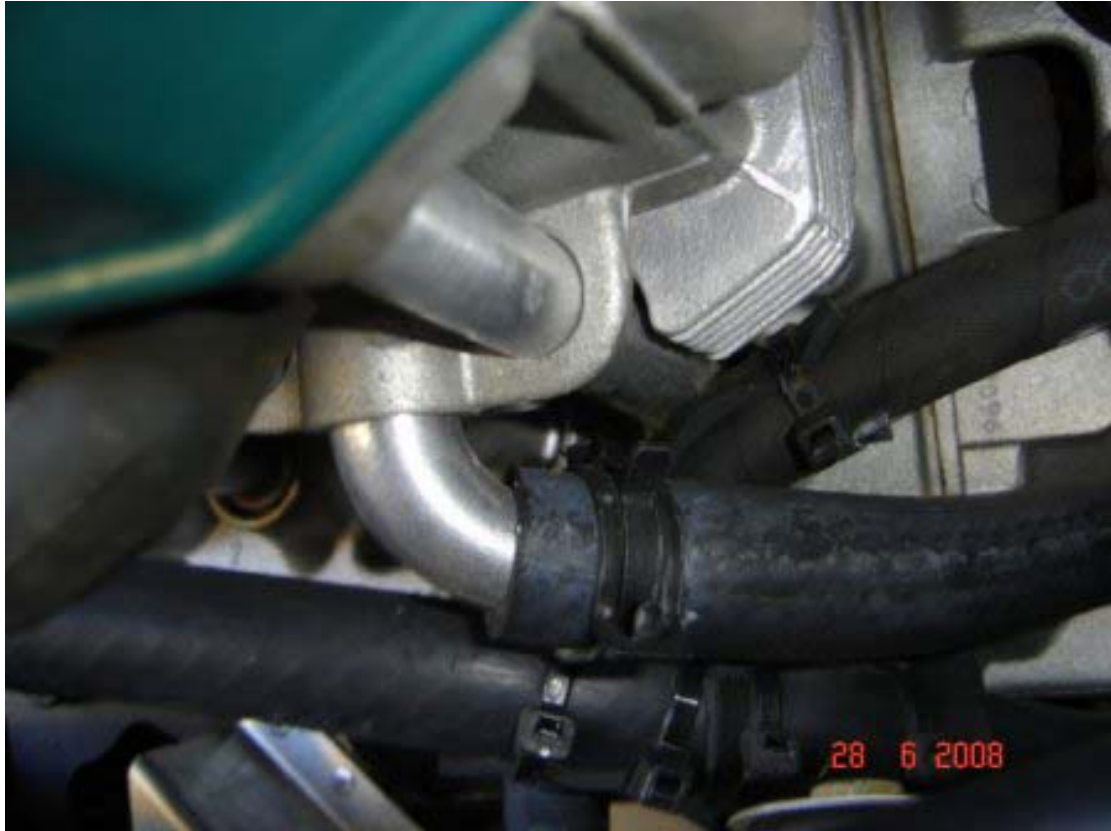
**Tip No 4:** *I have seen some instances of the engine frame bolt heads chafing the cooling hoses on the underside of the Rotax engine. Even if the hoses were not contacting the bolt heads at installation the hoses can sag a little with time and vibration and rub on the bolt heads. We need to cable tie some rubber insertion at these points to prevent chafing.*
